Mobile Intel[®] Pentium[®] 4 Processor-M

Specification Update

December 2004

Document Number: **250721-028**

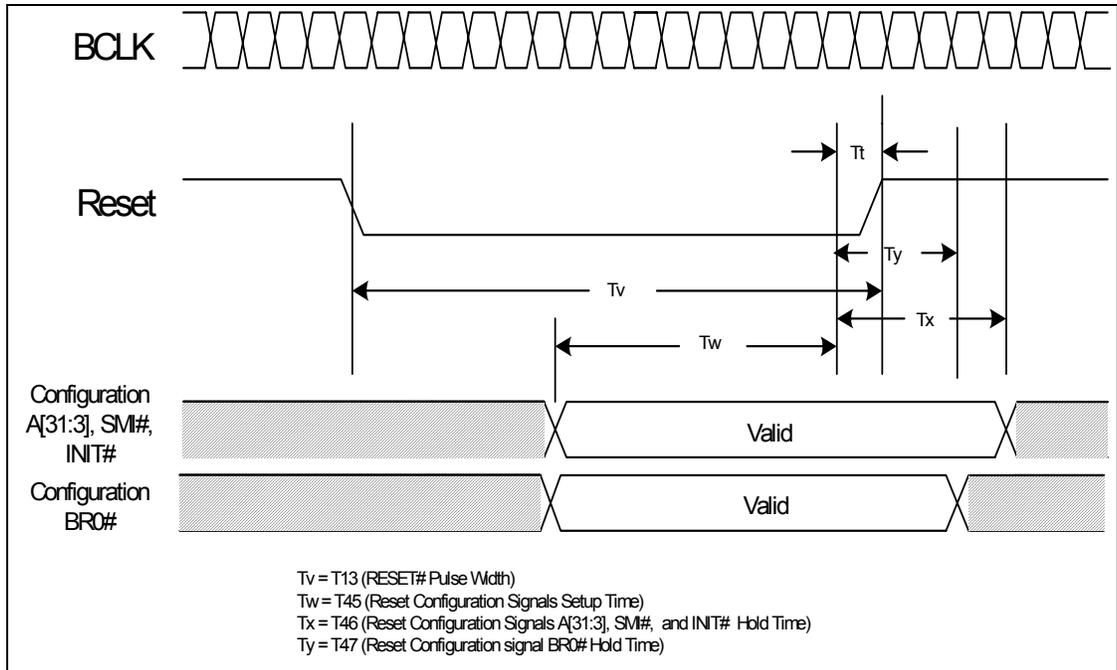
Figure 13. System Bus Reset and Configuration Timings

The BR0# maximum hold time has changed to 2 BCLKs. This change will be shown in the “System Bus AC Specifications (Reset Conditions)” table and “System Bus Reset and Configuration Timings” figure of the *Mobile Intel® Pentium® 4 Processor - M Datasheet*. This change will be incorporated in the next revision of the datasheet.
